Sprinklers Prevent Tragedy in Two Health Care Facility Fires

Compliance with code requirements, activation of sprinkler systems, and proper staff actions saved lives in two recent Massachusetts fires.

INVESTIGATION REPORT

WOBURN NURSING CENTER FIRE

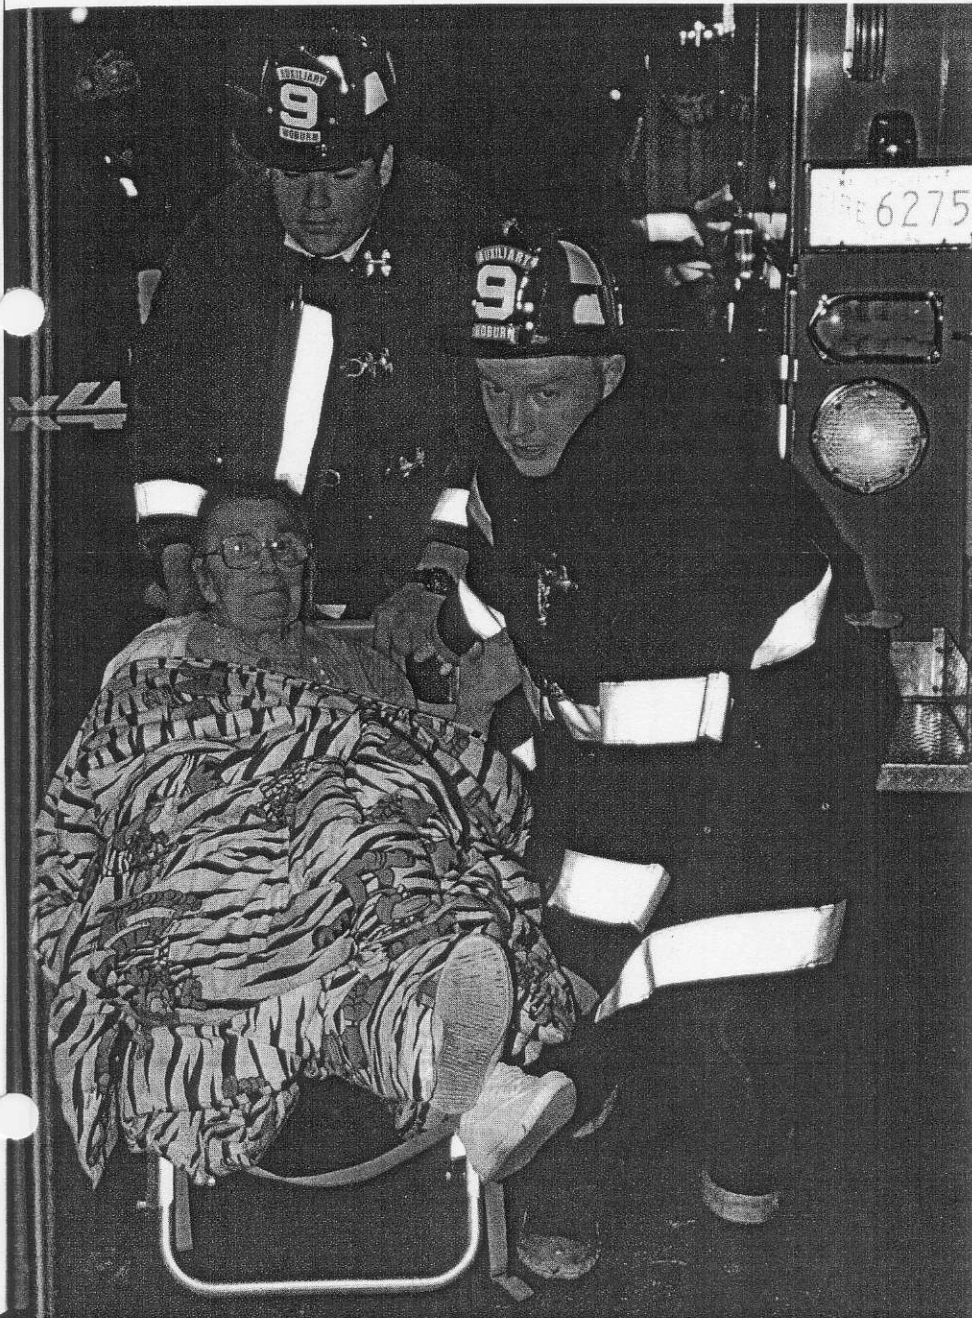
Firefighters evacuate a resident of the Woburn Nursing Center after leaking propane caused a fire and explosion.

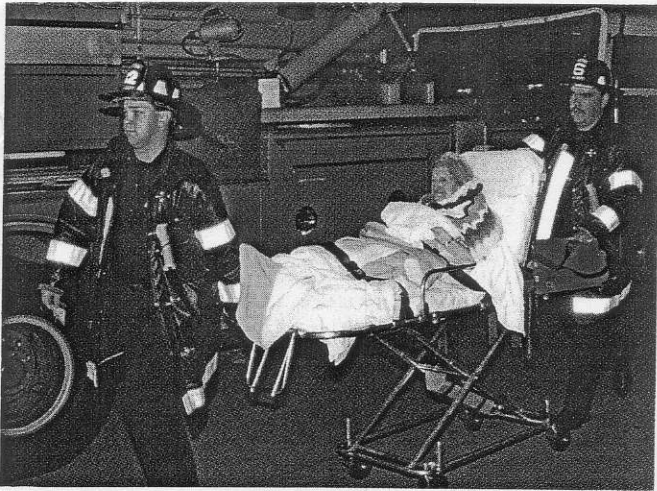
The nursing center's 101 residents were safely evacuated in 15 or 20 minutes and were taken to a school that was used as a temporary shelter.

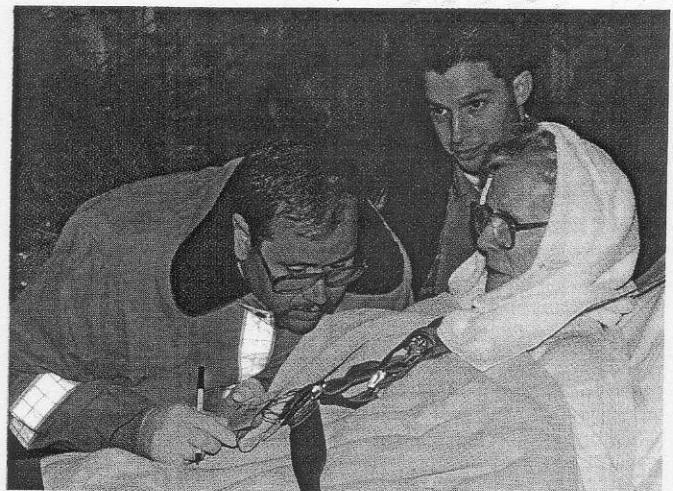
Emergency medical personnel check a resident's identity and vital medical data before she was transported to the temporary shelter and then to a hospital or nursing home.

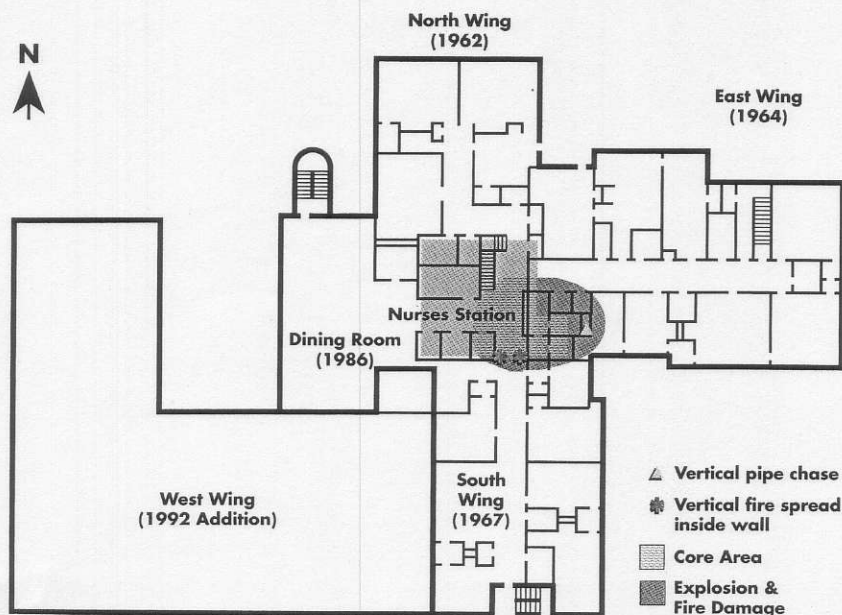
FIGURE 1

the additions were of light, noncombustible construction and were so located that the original structure was surrounded by new wings. Thus, the old wood-frame structure became the core area of the facility (see Figure 1).

Woburn Nursing Home, Floor 1

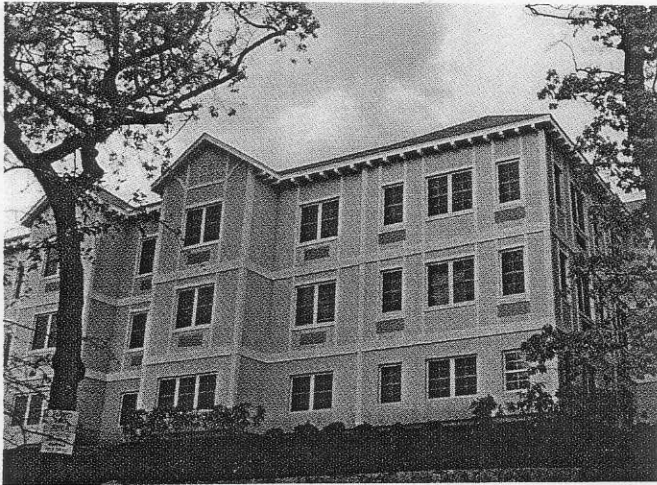
The fire and explosion occurred in the central core area on the first floor of the Woburn Nursing Center. Residents' room were in wings surrounding the core area.

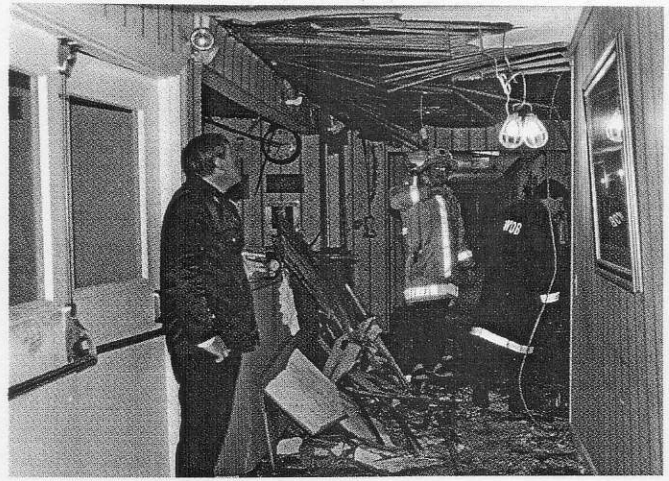
Explosion and fire damage in the core area of the nursing center extended from the first floor to the third floor, shown here. Fire doors at left closed automatically.
